Westway – a cycling assessment

Wheelrights were concerned about an apparent lack of provision for cyclists. Accordingly their *Routes Group* made a detailed inspection of the area on 4 February 2017. This report contains our findings. Recommendations are made on how to make it more cycle friendly.

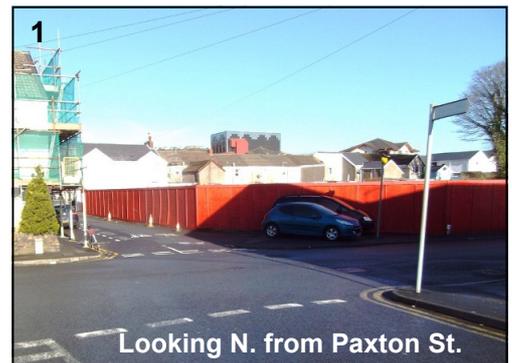
Looking N. from Paxton St.

This is an existing cycle route. Photo 1 shows where it crosses Glamorgan St. - Clarence Terrace and photo 2 the barrier immediately to the north of this.

A hazard for cyclist is that Glamorgan St. - Clarence Ter. is a 'rat run' and has priority. The barrier to the north is not particularly cycle friendly.

1. Remove the Glamorgan St. - Clarence Ter. priority.
One way of achieving this would be to provide broken lines (like those in Photo 1) on both sides of this junction so that neither direction has priority.
2. Replace the William St. barrier by bollards.

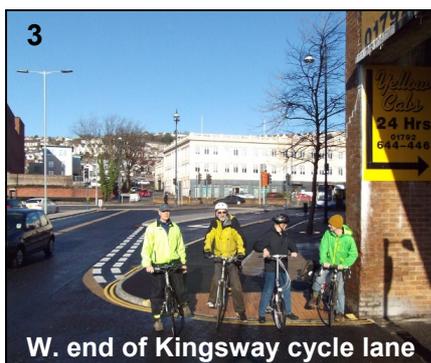
W. end of Kingsway cycle lane

The west end of the Kingsway cycle lane leads on to a shared use path on the east side of Dillwyn St. This path lacks continuity across the entrance in front of the cyclists in Photo 3. From here to Singleton St. it is of acceptable width (3m). A Kingsway crossing is needed for northbound cyclists.

1. Make the shared use path continuous across minor junctions along Dillwyn St.
2. Provide a Kingsway crossing for northbound cyclists.

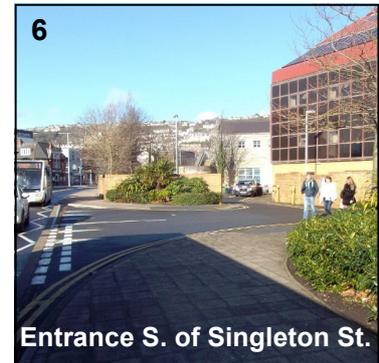
The path lacks priority across the entrance shown in Photo 6.

1. Upgrade the path along this section to Active Travel Act (ATA) shared use standards. This will at least involve providing continuity across the junction shown in Photo 6 and either a priority or a controlled crossing (eg to DE025 or DE026 of the ATA Guidance.) at the bus entrance (Photo 7.)

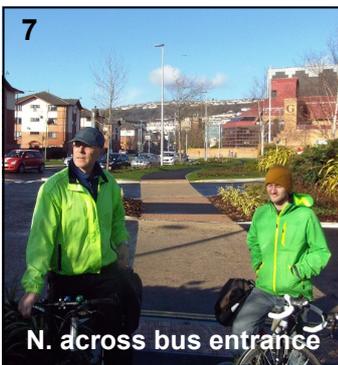
The crossing of the bus station entrance (Photo 7) by the wiggly path (Photo 7 background) lacks continuity across this entrance.

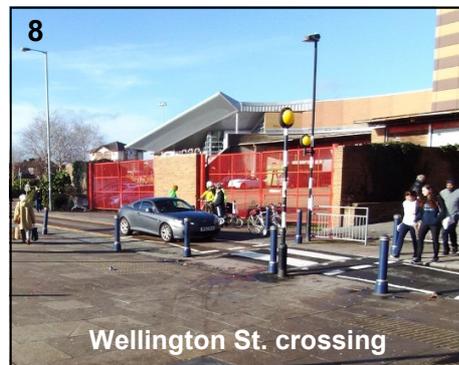
Cycle options south of this are not clear. Provision needs to be made to cross Wellington St. to get to Tescos, eg by the zebra crossing shown in Photo 8, and to travel east. Cyclists travelling west from Tescos need to be able to get to Westway, there either to turn left or cross to Clarence Terrace. Also how to access the west end of the new Westway Toucan crossing is not clear.

2. Provide both a crossing of Wellington Street to access Tesco (eg alongside the zebra shown in Photo 8; ATA: DE043 applies.) and a means for cyclists to cycle east. This could involve a contra-flow on the north side of Wellington St. as this is one way west, alternatively, as there's plenty of space outside Tesco, a two-way lane on the south side of Wellington St.

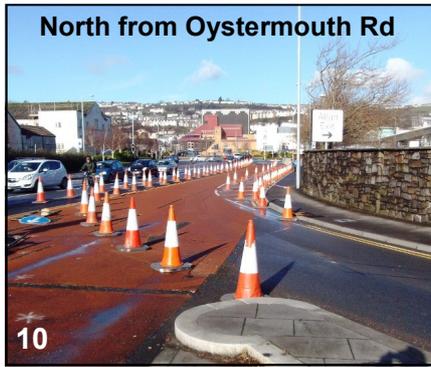
Photo 10 (overleaf) shows construction work underway at the time of the visit. The bus lane was then in use by southbound buses. We note that since then the footway has been widened to provide a shared use path which continues round the bend shown in Photo 10 to the Toucan crossing of Oystermouth Road (Photo 11). At the time of writing the work here was still in progress, but the provision appears to be what is needed.
