Alexandra Road shared use path audit

Introduction

The purpose of this audit is to identify the work needed on this path to bring it up to standard. It draws on advice from John Meudell (a CTC Director, knowledgeable in these matters) who on a recent visit to Swansea drew attention to a number of shortcomings on this path.

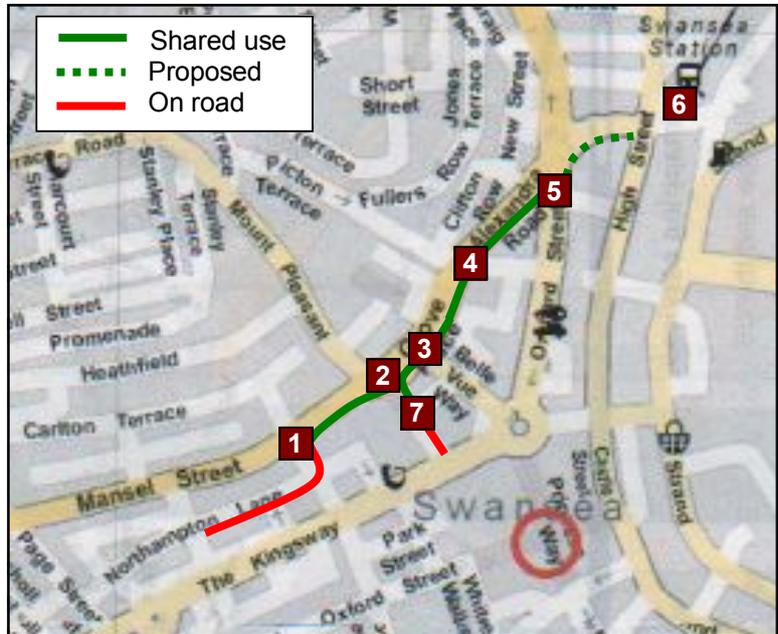
1. Craddock Street

There is confusion at this junction. The marked crossing indicates that this is the cycle route to Sketty, as did the sign (1b) (until we turned it to point down Craddock Street). This sign needs to be relocated, probably on the twin posts further west (1a) to make it clear that cyclists turn left on to Craddock St. An arrow (indicated) plus a bike sign is also needed. The sign by the bus stop on Craddock St. needs turning to indicate the right turn on to Northampton Lane. It also needs adjusting to be clear of buses. Road markings on Northampton Lane need changing to indicate cyclists go straight on and a right turn sign added at end.

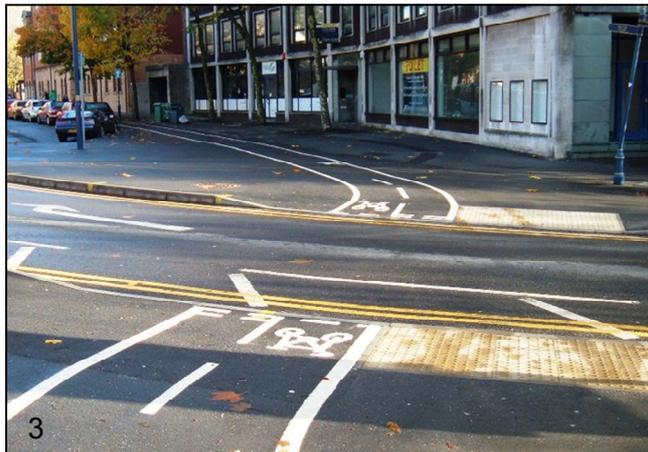
3. Bellevue

This crossing needs to continue across Bellevue, either as a coloured strip or as a zebra crossing (preferred). Bellevue being one way north there is not a problem with traffic back up here.

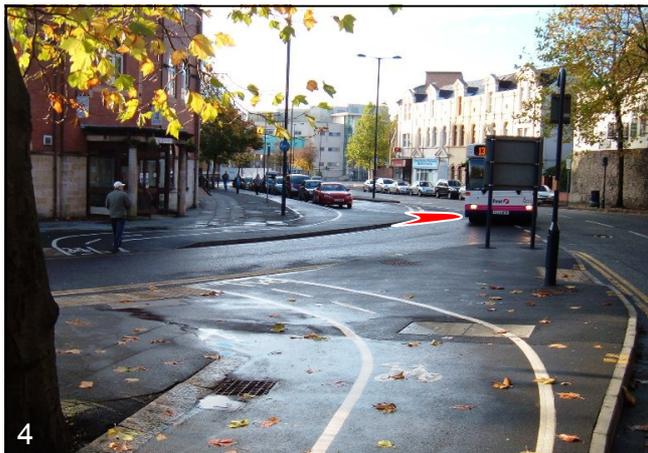
4. Pleasant Street

This is a dangerous crossing particularly for the eastbound cyclist. Traffic needs to be slowed. This could be achieved cheaply by forming an over-run zone to tighten the curvature. This is indicated by the red area adjacent to the bus. In addition the path should be marked across the street. There is space to accommodate one large vehicle without blocking Alexandra Road.

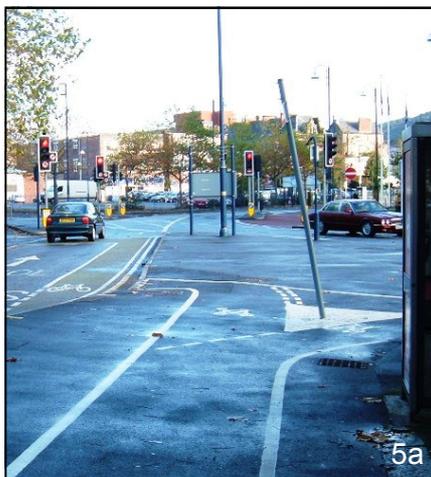
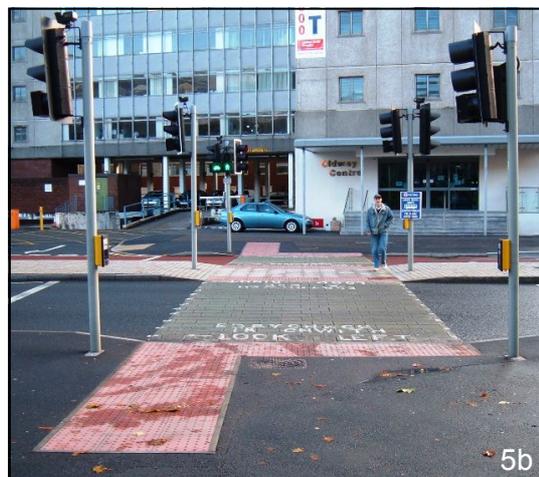
5. Orchard Street

Straighten the bent signpost (5a)!

Cyclists for the station following the Metro lane up Orchard Street turn right either on to Alexandra Rd or on to the pavement (in the background in 5b). The former is confusing as it is not clear to a cyclist that the left metro lane stops here. The latter is safer but currently illegal.

Make the pavement on the SE side of Alexandra Road shared use from the Toucan (5b) to High Street. A sign pointing to High St Station would be appropriate in front of the car in 5b.

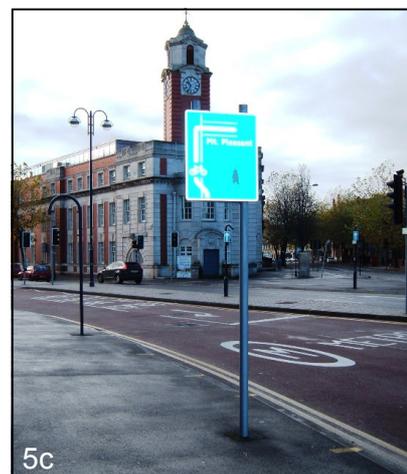
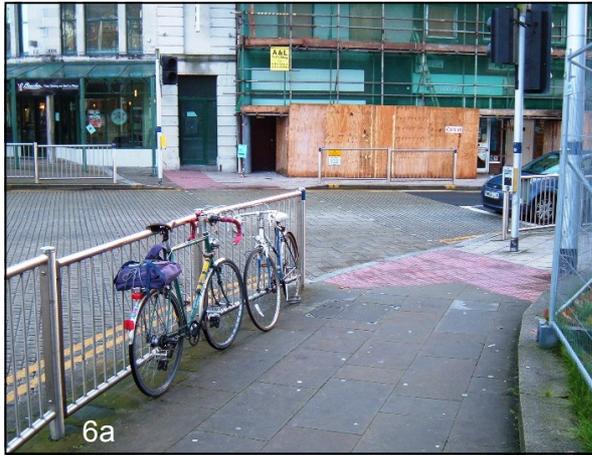
The sign (5c) identifies the Toucan crossing of Orchard St. for the westbound. It implies that at least a short length of the pavement at the top end of Orchard Street (from where the photo is taken) is shared use. NB: for consistency with the other signs this sign could usefully have "Sketty" and "Uplands" added to it

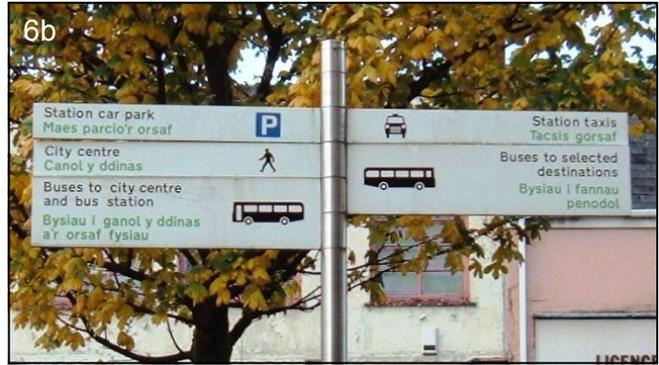
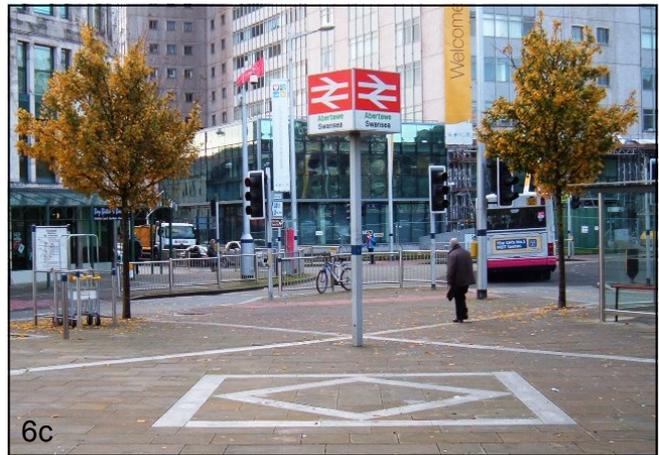
6. High Street Station

If the SE side of Alexandra Road is made shared use the crossing of High Street (6a) should be converted to a Toucan to link to the station.

The signs 6b ignore cyclists. A better location – at least for a sign indicating routes south and west for cyclists – would be on the post holding the station logo (6c).

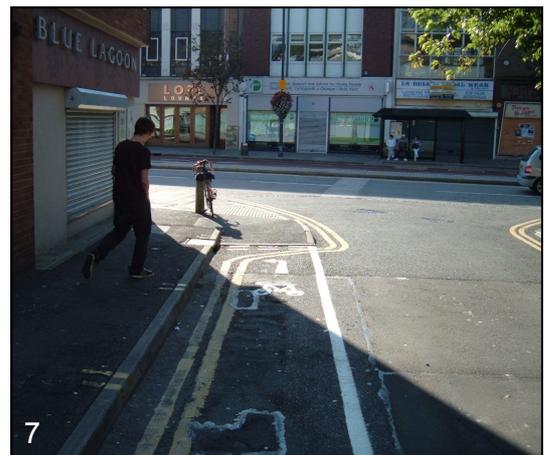
7. Dynevor Place Contra-flow

The marked cycle lane linking Grove Place (right edge of photo 2a) has been erased – it should be reinstated.

The pavement from the left turn arrow (7) to the Toucan across the Kingsway needs to be signed as shared use. This sign needs to be visible to a cyclist turning left off the contra-flow.
