Westway – a cycling assessment

Wheelrights were concerned about an apparent lack of provision for cyclists. Accordingly their *Routes Group* made a detailed inspection of the area on 4 February 2017. This report contains our findings. Recommendations are made on how to make it more cycle friendly.

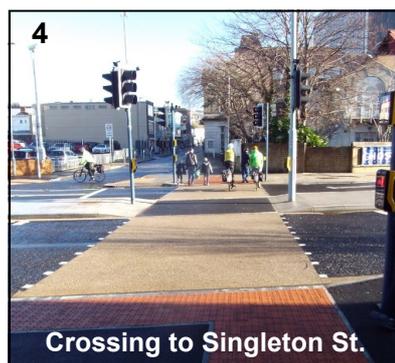
The west end of the Kingsway cycle lane leads on to a shared use path on the east side of Dillwyn St. This path lacks continuity across the entrance in front of the cyclists in Photo 3. From here to Singleton St. it is of acceptable width (3m). A Kingsway crossing is needed for northbound cyclists.

Crossing to Singleton St.

1. Make the shared use path continuous across minor junctions along Dillwyn St.
2. Provide a Kingsway crossing for northbound cyclists.

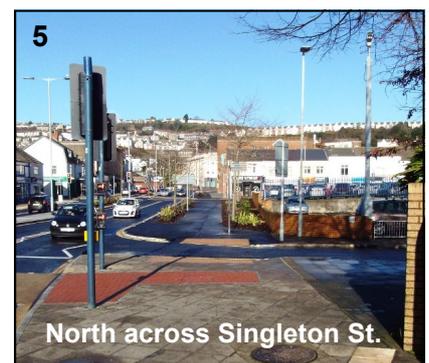
North across Singleton St.
